HESS SOFTBALL FIELD COMPLEX EVALUATION

Prepared for
Centre Region Council of Governments
Centre Region Parks and Recreation

October 12, 2009

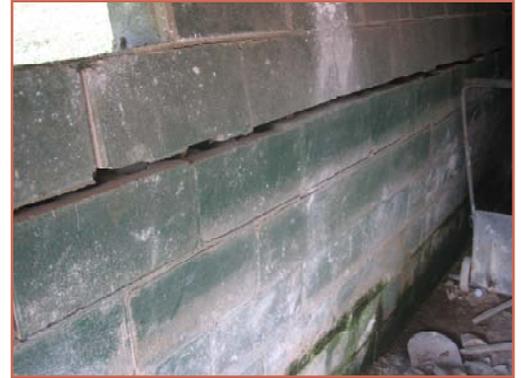
A drainage gutter runs under the floor of the first base dugout. A wooden floor is laid over the concrete gutter. In heavy rains, the gutter overflows into the dugout. The concrete gutter should be replaced with a culvert and channeled to an appropriate location where it can drain away from the field.

The steps that lead down the hill to the first base dugout entrance are in poor condition and create a safety hazard. They should be removed and replaced.

- Install new chain link fence in front of the third base dugout.
- Remove and replace the steps that lead to the first base dugout.
- Have an electrical lineman evaluate the condition and safety of the light pole outside the right field fence that is leaning.

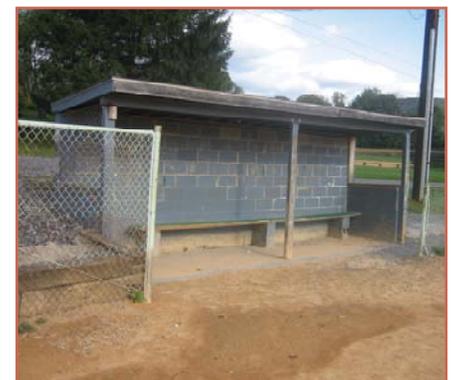
Dugouts – There are dugouts measuring 20’ x 6’ on both sides of the field. The first base dugout is adequately protected by fencing. The third base dugout is in good condition, however, it is not protected by fencing. A storage area has been added to the backside of the first base dugout. The back wall of the storage area is collapsing. The best solution is to remove the storage area, leaving only the dugout. Both dugouts need painted and re-roofed.

- Remove and replace backstop with one that will better contain foul balls.

- Replace artificial turf batter's boxes with clay brick.
- Install a drainage culvert at the first base dugout.
- Renovate the infield to provide a good, well drained playing surface.
- Rehabilitate the outfield turf – re-grade, aerate, apply turf amendments, and over seed.

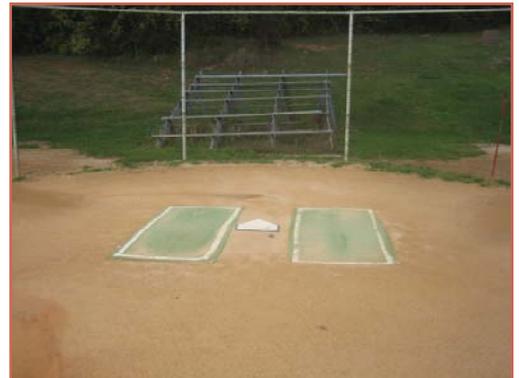
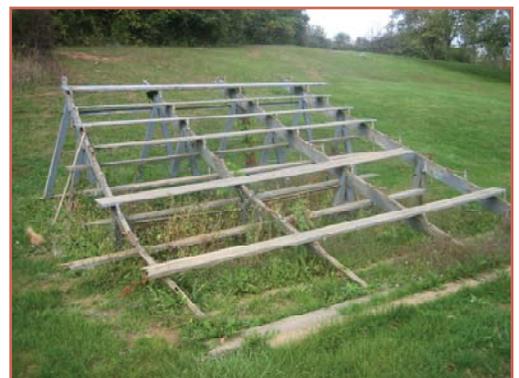
Backstop – Light duty garden fence that is 9½' high and 30' long. This is a very small backstop. The backstop should be removed and replaced

Fencing – There is no baseline or fouling fencing on this field. Fencing should be installed in front of both player benches. The outfield has a 6' high chain link fence around it that is in good condition

Infield – The infield is Diamond-Tex infield mix but it has not been replenished sufficiently to maintain proper grades and drainage. Artificial turf is installed for the batter's boxes. Although there are no specific standards prohibiting this, the change in playing surface from dirt to artificial can create unexpected circumstances for players that can result in injuries. We recommend replacing the artificial turf with clay brick. Water from the hill outside the first base side collects in front of the player bench and along the base line. A drainage swale should be constructed at the base of the hill to carry the water away from the field.

The infield is in the foul ball and home run zones of Field 1 creating significant safety hazards. The field should be moved 50' directly out the right field line.

Player Benches – There are player benches located on both the first and third base sides of the field. Both need chain link fences installed to protect players from foul balls. The seat boards need replaced on the first base side bench.

Spectator Seating – Most of the spectator seating is on the grassy hillside located along the first base and behind the backstop. It provides a good view of the field. There is a set of bleachers directly behind the backstop that are extremely unsafe. These bleachers should be removed immediately. There is another set of bleachers along the third base line that are in poor condition and should also be removed. Both should be replaced and located in areas outside the foul ball zone from Field 1.

- Install chain link fence in front of both player benches.
- Remove the bleachers from behind home base and along the third base side. Replace in a location outside of the Field 1 foul ball zone.

- Construct a regulation backstop.
- Replace artificial turf batters boxes with clay brick.
- Replace the seat on the first base side player’s bench.
- Renovate the infield to provide a good, well drained playing surface.
- Rehabilitate the outfield turf – re-grade, aerate, apply turf amendments, and over seed.
- Construct a drainage swale at the base of the first base side hill to carry the water away from the field.

- Relocate the field 50’ directly out the right field foul line.
- Install chain link fence in front of both player benches.
- Remove the bleachers from behind home base. Replace in the new field location.
- Remove the bleachers from the third base side. Replace in the new field location.
- Construct a regulation backstop on the new field.
- Replace artificial turf batters boxes with clay brick.
- Build a new infield to provide a good, well drained playing surface.
- Rehabilitate the outfield turf – re-grade, aerate, apply turf amendments, and over seed.
- Construct a drainage swale at the base of the first base side hill to carry the water away from the field (if this is still needed once the field is moved).

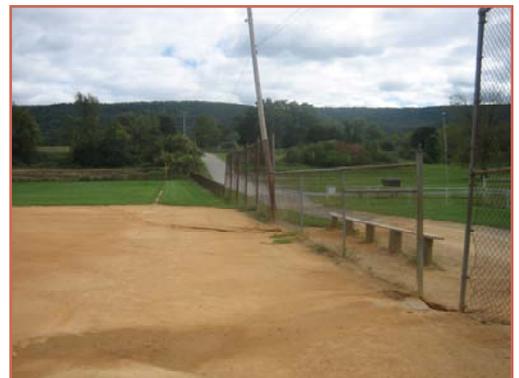
Backstop – Chain link fence that is 16’ high behind home plate with 12’ high side panels extending in each direction. Fencing is rusted and bowed. It is in fair condition.

Fencing – All fences are chain link. Right field fence is 6’ high in front of the player bench; 10’ high for 40’ beyond the bench; and 4’ high to the outfield fence. The outfield fence is 6’ high. There is no fence along the left field side or in front of the left player bench. Fences are badly bowed and rusted coming loose from the fence posts. The fence and backstop do not sufficiently protect against foul balls going into the road and onto Field 1.

- Remove and replace the backstop with one that will better contain foul balls.
- Remove and replace all fencing. Right field fence should contain foul balls from going into the road. Close the road.
- Replace artificial turf batters boxes with clay brick.
- Renovate the infield to provide a good, well drained playing surface.
- Rehabilitate the outfield turf – re-grade, aerate, apply turf amendments, and over seed.

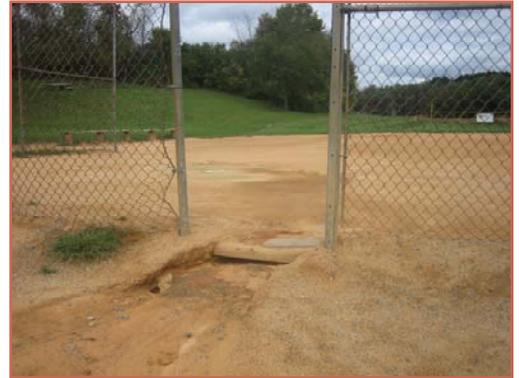
Other Comments – The right field line is within eight to ten feet of the entrance road, which creates a significant foul ball hazard for cars entering on that road. Higher fencing should be installed to protect vehicles from foul balls. The main electric lines coming into the site also travel along the road immediately adjacent to the field. One of the utility poles is leaning significantly. A lineman should be brought in to evaluate the condition of the pole to see if it needs replaced. Plans should be made to relocate these lines in the future.

At certain times of the evening, the sun shines directly into the eyes of the left and center fielders, and players at short stop and third base. In the morning, the batters look into the sun. Games could be scheduled to avoid this time of evening or a shade screen could be installed.

- Install new fence in front of left player bench.
- Close the entrance road to vehicular traffic before the traffic passes by the field.
- Remove existing bleachers. Replace as funds are available or demand dictates. There is plenty of seating along the left field hillside.
- Have an electrical lineman evaluate the condition and safety of the utility pole near first base that is leaning.

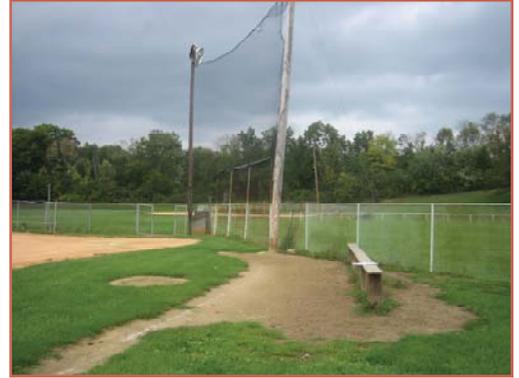
Player Benches – There are player benches located on both the first and third base sides of the field. The first base side player bench is in the home run zone for both Field 1 and Field 2. A fence and mesh net barrier has been constructed around the bench area to protect players. Chain link fencing should be installed in front of both player benches when the field is relocated.

Spectator Seating –The bleachers along the third base line are in poor condition and should be removed. New bleachers should be located in an area outside the home run zone from Field 1.

- Move the entire field 50’ directly out the left field foul line. This will provide sufficient field spacing for this field.
- Install chain link fence in front of both player benches.
- Remove and replace the bleachers.

- Install a new regulation size backstop.
- Replace artificial turf batters boxes with clay brick.
- Re-build the infield to provide a good, well drained playing surface.
- Rehabilitate the outfield turf – re-grade, aerate, apply turf amendments, and over seed
- Install new outfield fencing.

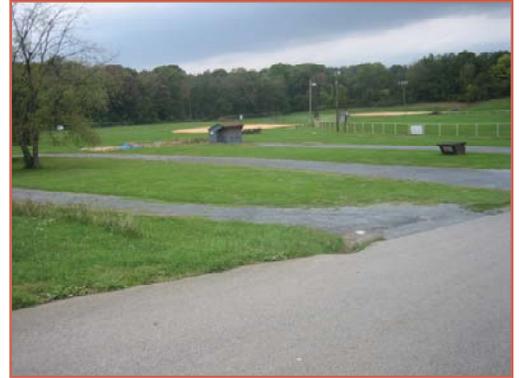
Aggregate area between the concession stand and Field 1

This area is unusable and unsightly. It should be turned into a more useable space by re-removing the gravel, re-grading, and planting grass, trees, and other vegetation. At least one picnic shelter could be constructed in the area as well.

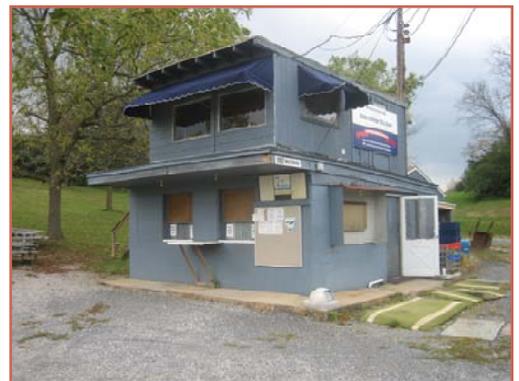
The back wall of the maintenance shed that is attached to the building is collapsing. If it falls, the roof of the shed will collapse as well. This is a dangerous situation. The wall should be repaired immediately or the shed should be removed.

- Close the entrance road to vehicular traffic beginning at the south east edge of Field 3. Make it available only as a service road to the concession building.
- Repair the collapsing concrete block wall on the northeast side of the maintenance shed or remove the shed.
- Comply with ADA standards for outdoor recreation facilities.
- Remove the deep fryer and the prep grill from the concession stand.
- Complete upgrades to the concession stand as required by the fire code inspection Estimated cost is unknown until the fire inspection is completed.
- Close the restroom building and use portable restrooms
- Repair the roof in the press box.
